REHABILITATION AND STRENGTHENING OF
BURLINGTON NORTHERN SANTA FE RAILWAY
BRIDGE 482.1 OVER THE MISSISSIPPI RIVER
MEMPHIS, TENNESSEE

John W. Hronek & Ron G. Berry
HNTB Companies
1201 Walnut, Suite 700
Kansas City, Missouri 64106
Phone - 816-472-1201
Fax - 816-472-5013
September 2000

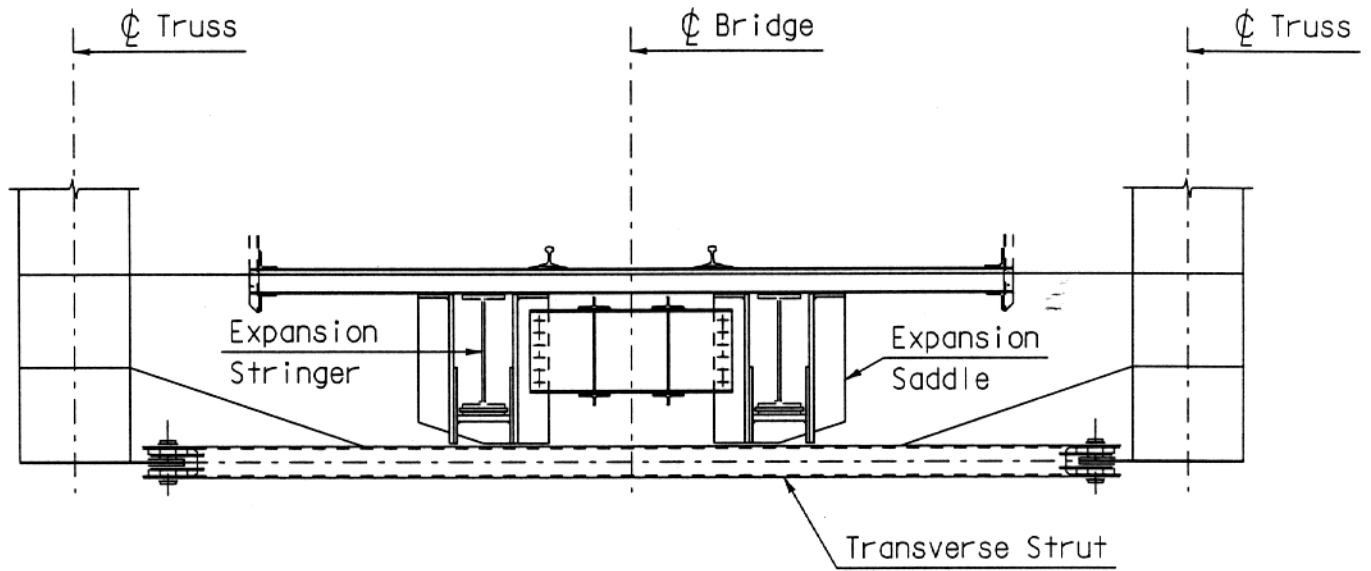
Figure 2. Typical Section - Expansion Joint

The field inspection in 1994 verified that the top rollers were rusted to the pin and stringer bearing plate and that the oil holes were plugged with dirt. The assemblies at the expansion joints shifted towards the centerline of track and the inside of the assembly were wearing into the stub bracket plate since the link-pin arrangement was not functioning as originally intended.

- The top angles of the stub brackets were very badly corroded and cracked.
- The top angles of the cross frame in the stringer span adjacent to the expansion joint were severely corroded.

- Holes in the floorbeam web on the backside of the expansion joint at the bottom of the stringer to floorbeam connection had developed. A reinforcing plate had been riveted to the floorbeam web on the expansion joint face to strengthen this area. This plate was added when the other expansion joint repairs were made.

- The floorbeam web below the bottom of the stringer was buckled locally due to a horizontal force induced into the web by a force couple from the stub stringer.

- The transverse strut connecting the lateral bracing member in the expansion panel to the bottom chords was also heavily corroded. The expansion joint struts had been repaired in the past by splicing angles and plates to the member. The original configuration of the transverse strut has contributed to the deterioration of the member as the original top member was fabricated of a 12" channel with the flanges turned up. By design, this detail retained debris and water. The pin connections at the lateral connections to the chord gusset plate were also heavily corroded.

The leaking of the fire protection waterline expansion joints had exacerbated the extensive deterioration at the expansion joint panels. Weep holes drilled into the 12" channel were not effective because of accumulated debris.

After meeting with the BNSF, it was decided to detail an assembly that would require minimal maintenance in the future. The following design concepts were adopted. See Figure 2 for a typical section at the expansion joint.

A rolled beam section fabricated to be installed as a complete unit replaced the expansion panel stringers.

Review of the existing plans indicated that a stringer saddle device similar to what has been used at other BNSF bridges could be designed to handle the anticipated magnitude of movement at the expansion joint. The saddle connection utilized existing rivet holes in the floorbeams. The use of the saddle would cause some increase in the eccentricity of stringer reaction to the floorbeam; however, details were developed to minimize eccentricities. Expansion in the truss floor system was accommodated through the use of a Teflon faced plate attached to a saddle bracket, allowing the stringer span to expand and contract. The saddle and bracket was designed to accommodate a total movement due to temperature and live load of 20

inches. The assembly was made up of plates welded to form the saddle. The saddle was designated fracture critical material and was stress relieved after fabrication.

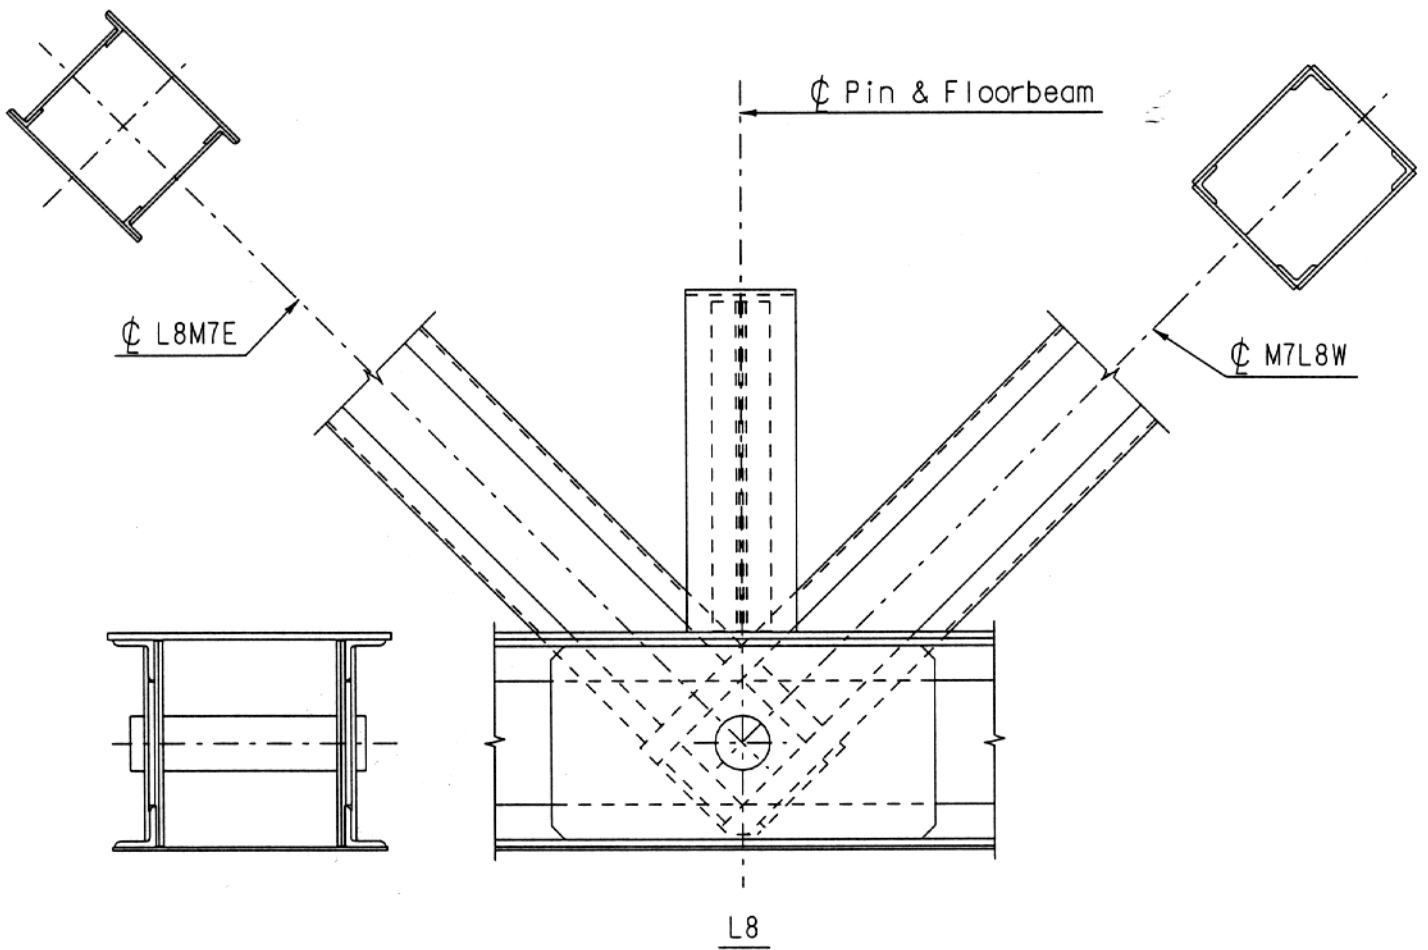
Figure 3. Truss Joint L8

In October 1998, the Burlington Northern Santa Fe Railway Company contracted with HNTB to investigate truss pin wear on Bridge 482.1 over the Mississippi River in Memphis, Tennessee. The specific area of concern was the group of pin plates around the lower truss pin at joint L8 of the suspended truss span. A bridge inspector had noticed a 3/8" gap between the pin's surface and the surrounding plates, 1/8" wear of the pin and excessive movement of the pin under live load. HNTB's

The lower truss joint at panel point L8 comprises the lower chord member, two opposing, box shaped, web diagonals and an 8" diameter pin with end caps (Figure 3). Since there is no vertical member framing into the joint, all vertical floorbeam loads are carried through the truss pin and into the truss diagonals. Any repair scheme would have to insure that the loads from the pin continue to be transferred into the diagonals as well as arrest the movement of the pin.

The decision was made to design a system of tension ties that would encompass the pin and transfer the pin load entirely through this new system into the diagonal truss members. In effect, the proposed system would clamp around the pin and transfer the forces further up the diagonal, relieving the need for bearing between the pin and the pin plates.
